Dorothea Dix Park

Master Plan Joint Workgroup Building Tours

Date: Tuesday, May 22 + Thursday, May 24, 2018
Time: 4:00pm – 6:00pm
Location: Dorothea Dix Park

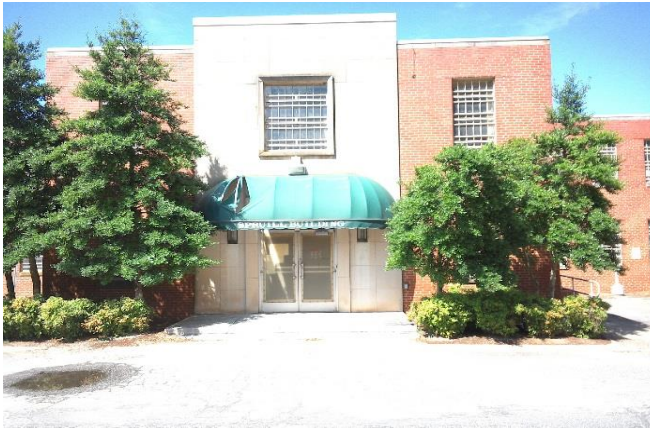
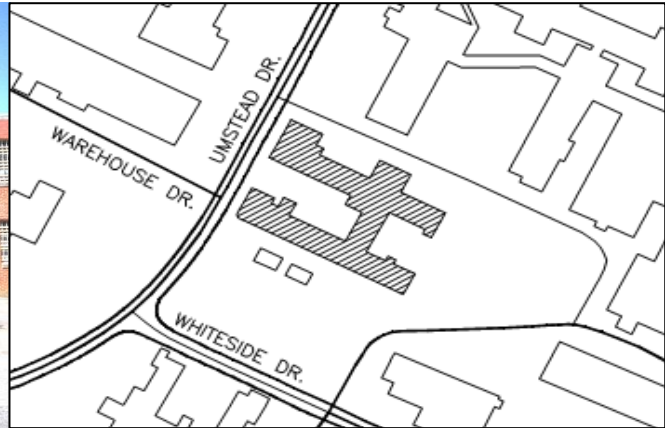
Spruill

Skin:	Brick veneer.
Windows & Doors:	Painted steel windows with single-pane glass and precast concrete sills.
Fascia & Soffits	None.
Other details:	Precast concrete entry, fabric entry canopies, metal parapet coping, tall chain link fencing enclosing courtyards and exterior stairwell, painted steel handrails.
Notes:	Overall condition of exterior is fair to poor: All steel windows and flashing rusted and windows are not energy efficient, all rusted steel to be painted, recommend window replacement, fabric canopies have torn and need replacement, exterior brick needs tuck-pointing at each window location, brick and precast sills require cleaning, exterior steel handrails are rusted and require paint.

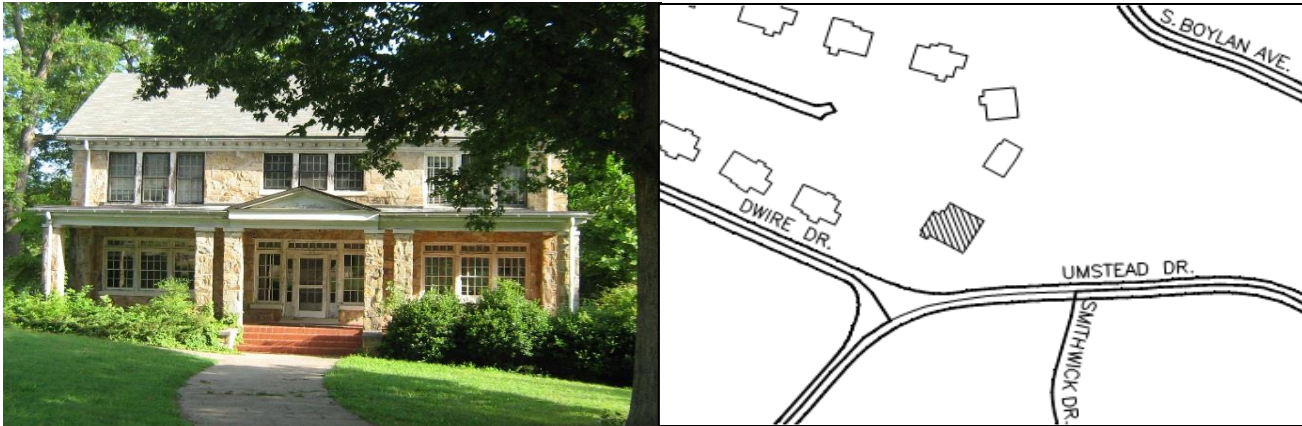
Superintendent's House

Skin: Two-story stone masonry
 Windows & Doors: Wood-framed windows and doors with single-pane glass, precast concrete sills, rear wood garage door with glass.
 Fascia & Soffits: Ornamental wood fascia and soffits
 Other details: Covered front porch with wood framed roof and stone columns, brick front porch steps and floor, stone chimney, side entry aluminum canopy with steel column, rear painted steel fire escape and posts.
 Notes: Overall condition of exterior is fair: Wood windows and doors are in disrepair and need caulking and painting, steel lintels need scraping and painting, all wood soffits and fascia need scrape and paint, precast sill joints need point up, wood porch ceiling needs paint and rotted boards need replacing, side porch aluminum awning is dirty and steel column needs paint, various stone joint point up needed throughout, rear steel fire escape is rusted and needs paint, wood garage door in disrepair, rear concrete site retaining walls cracked and shifted, crawl space vents are missing and need replacement, gutters need cleaning.

Type: Gable style with asphalt shingles
 Age/Remaining Life: Estimated age 5-10 years old.
 Roof Primary: Painted metal gutters and downspouts
 Drains Secondary: None.
 Notes: Front porch asphalt shingles front porch need replacing, rear built-up asphalt flat roof needs replacing.

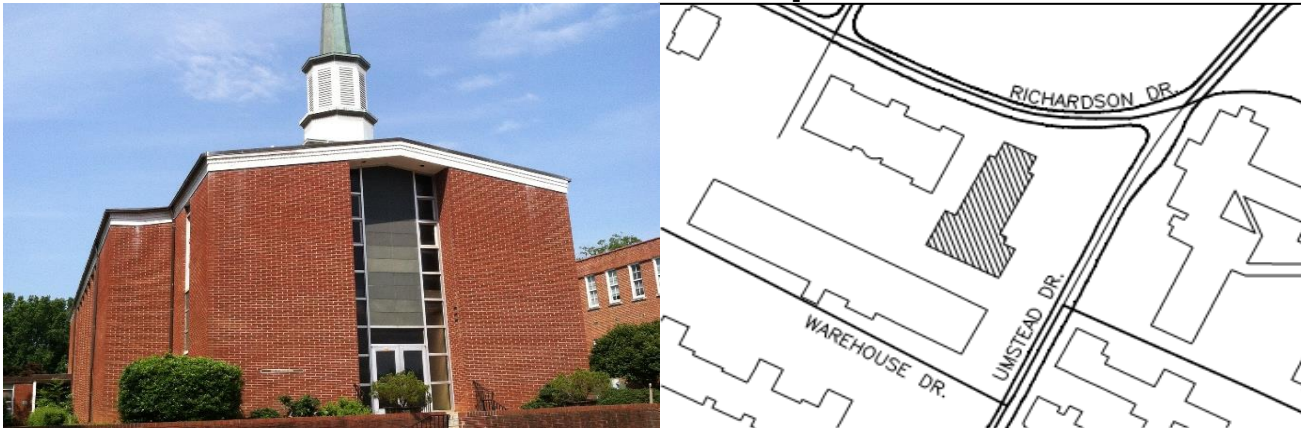
All Faiths Chapel

Skin:	Brick with stone panels between windows.
Windows & Doors:	Aluminum single-pane windows with precast concrete sills.
Fascia & Soffits	Painted wood fascia and soffits
Other details:	Copper coping, wood steeple with copper copings and steeple top and cross, granite steps, concrete landings, painted steel handrails, brick rear fence with painted iron gates, two wood post canopies.
Notes:	Overall condition of exterior is fair: Brick entry court needs tuck-pointing at joints, steel handrails are rusted and need paint, concrete entry walk is cracked, steps, brick, and entry landing need cleaning, paint is peeling on wood fascias, steel downspout outlets are rusted and paint is chipping, caulking at stone panels and at windows needs replacing, windows are not energy efficient and replacement is recommended, concrete sill is broken, wood canopy post needs paint, rear aluminum window gaskets are missing and cracked, wood window headers have water damage and need replacement, iron gates are rusted and need painting, copper fascias need cleaning.

Type:	Gable-style white TPO membrane
Age/Remaining Life:	Estimated age over 20 years. Roof may need replacement in the next 5 years.
Roof Primary:	Copper gutters and downspouts with painted steel outlet
Drains Secondary:	None.
Notes:	No known leaks.
